Technical Report REMR-CS-63
September 1999

Repair, Evaluation, Maintenance, and Rehabilitation Research Program

Repair and Rehabilitation of Dams: Case Studies

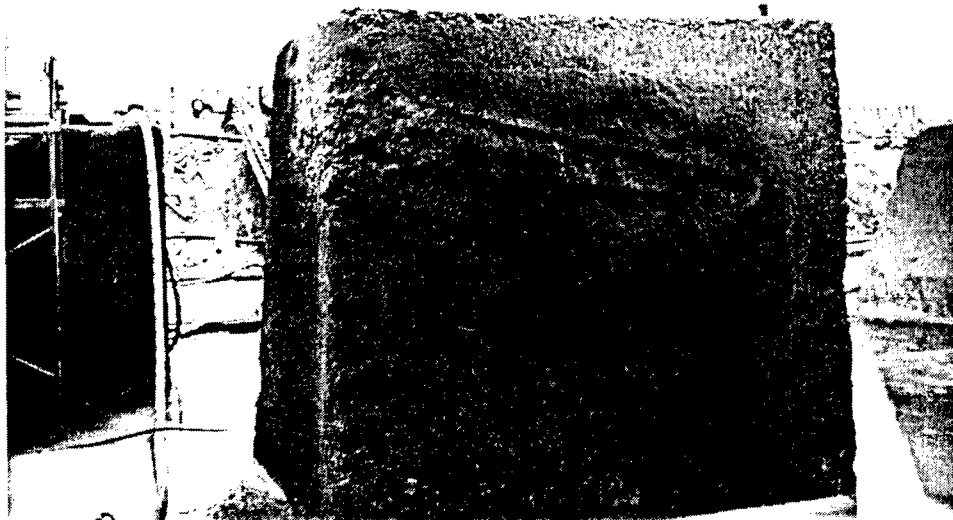
Stilling basin repair. After the inspection, workers began preparing the stilling basin slab for a 305-mm (12-in.) overlay of 34.5 MPa (5,000-psi) concrete with a low water-cement ratio (w/c). Over 10,000 hooked dowels were epoxied into the existing slab to anchor the overlay; then forms were erected, reinforcing steel was installed, piezometers installed in the slab were capped (two were left as permanent working piezometers), and over 1,529 cu m (2,000 cu yd) of concrete was placed. The overlay covered most of the damage to the baffle blocks. Damaged areas that extended above the overlay were repaired with shotcrete, a polymer improved cementitious mortar with aggregate that had a 28-day compressive strength over 48.3 MPa (7,000 psi) (Figure 7). It was also used to repair grout patches that had been damaged by erosion. Shotcrete was selected for these repairs because it is fast setting, has exceptional

Figure 7. Baffle Block repaired with shotcrete to restore original configuration and halt further erosion, Old River Control Structure (U.S. Army Engineer District, New Orleans 1988)

bonding properties, and has an abrasion resistance six times greater than that of conventional concrete. (Hassenboehler 1988).

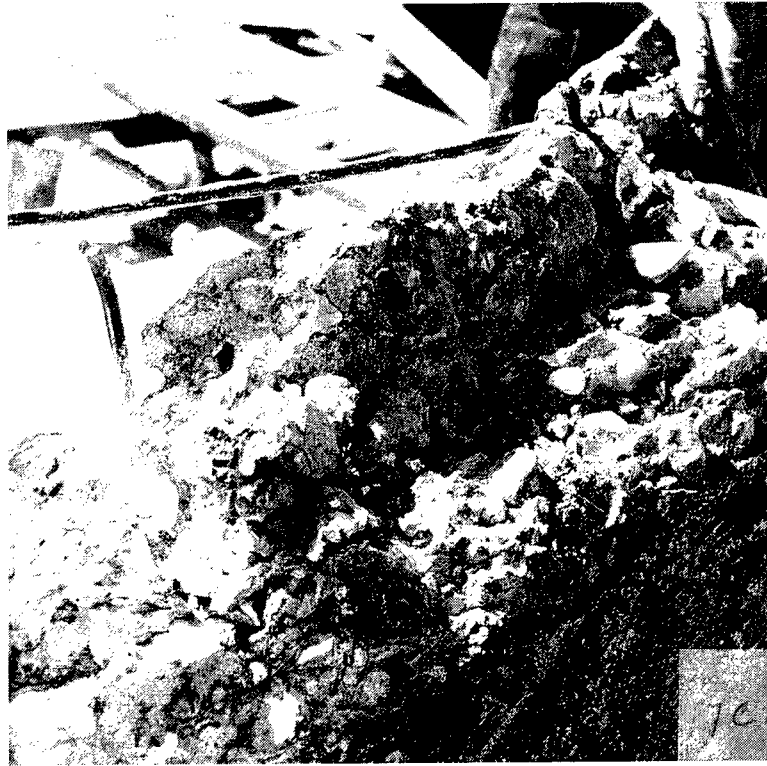
At the time of the Tenth Periodic Inspection (USAED, St. Louis 1997), the removal and replacement of columns on six of the eight bridge piers approved in the 1993 Major Rehabilitation Report were underway. Two of the columns that support the service bridge at Pier 16 had been removed. The periodic inspection team examined them and found excessive cracking, especially toward the top of the columns (Figure 8a). Generally, the concrete in the columns was in poor condition (Figure 8b).

Figure 8b. Severely deteriorated concrete in bridge support column from Pier 11, Mississippi Lock and Dam No. 24 (from U.S. Army Engineer District, St. Louis 1997)

The inspection team was recommended that the District Materials Engineer inspect the columns as they were removed to determine the severity of the deterioration. This inspection indicated conditions were as bad as believed; therefore, the team recommended that Piers 4 and 5, which were approved in the 1993 Major Rehabilitation Report but which had not been funded, be replaced. The recommendation was approved, and these piers were to be replaced under the current contract.

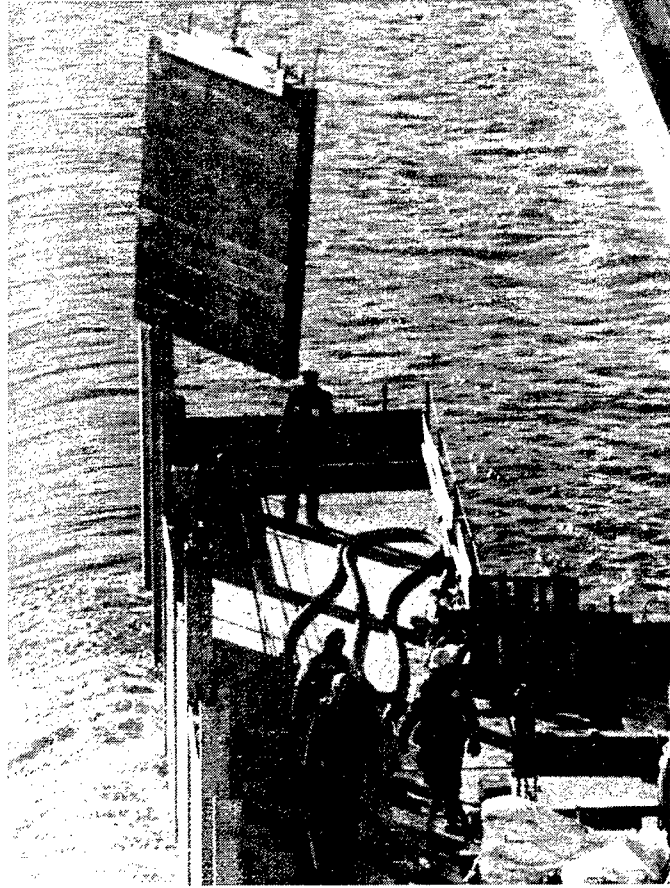
Barges were equipped to serve as floating work stations. To provide calm water for the divers, work barges were fitted with adjustable deflection gates. Once the barges were in place, a crane would lower the deflection gates into position to divert river flow around the work area (Figure 11).

Figure 11. Work barge with raised deflection gate, Little Falls Dam (from Intrusion-Prepakt, Inc. 1986)

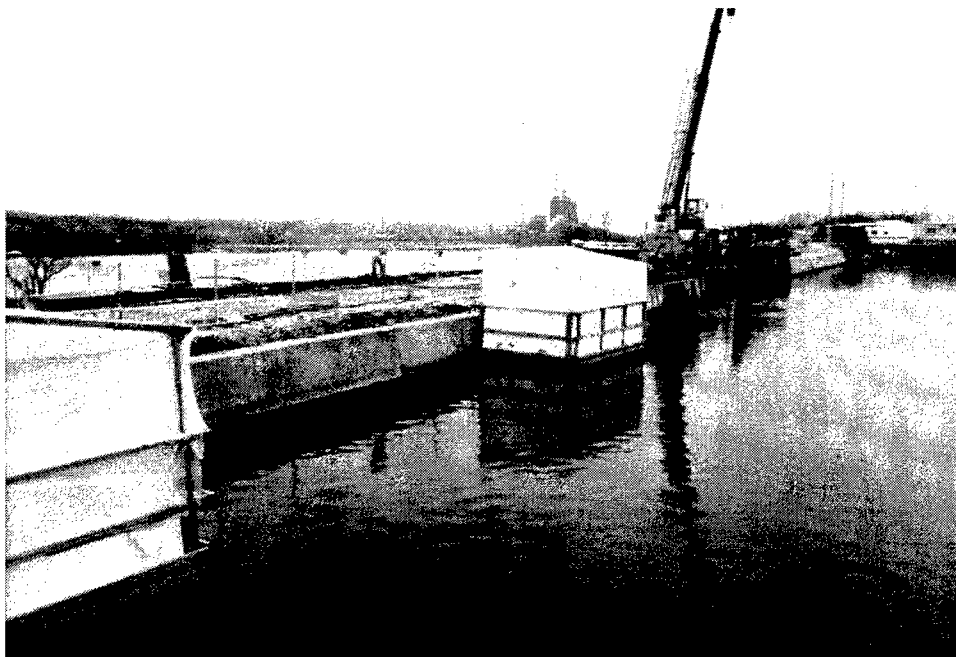
Figure 15. Head gate section on upstream face at Brandon Road Dam after rehabilitation

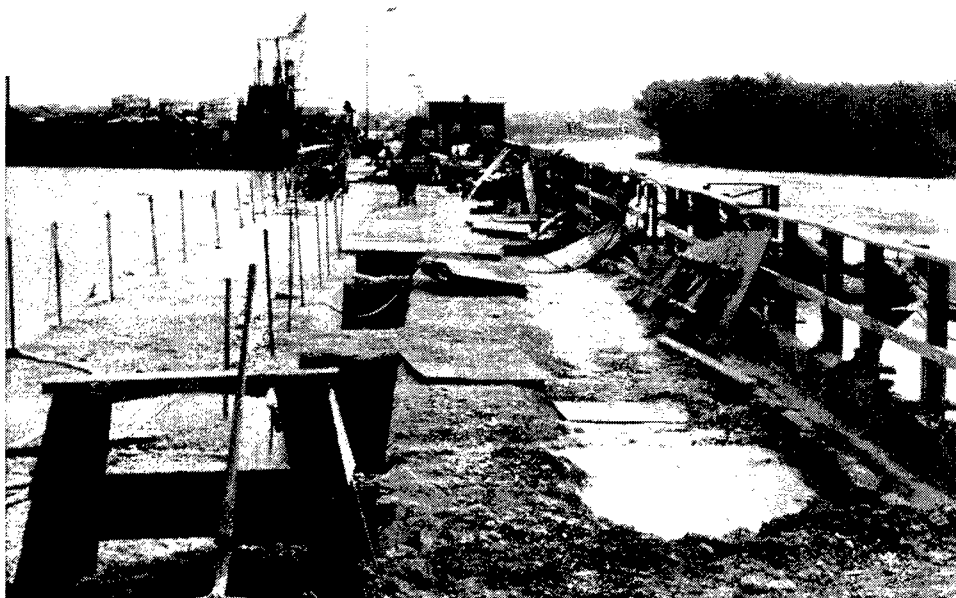
Concrete was removed to a depth of 229 mm (9 in.) on the horizontal surfaces of the head gate section. No. 6 steel bars at 305-mm (12-in.) spacings each way provided reinforcing for the horizontal surfaces of the head gate section. Additional reinforcing was added across the openings in the existing concrete. An asphaltic bond breaker was applied to the existing concrete before the conventional air-entrained concrete overlay was placed (Figure 15). Repair to the horizontal deck of the head gate section was similar to that of the sides; a 229-mm- (9-in.-) thick, unbonded overlay was used to replace deteriorated concrete (Figure 16).

Figure 16. Repairs to the horizontal deck of the head gate section at Brandon Road Dam

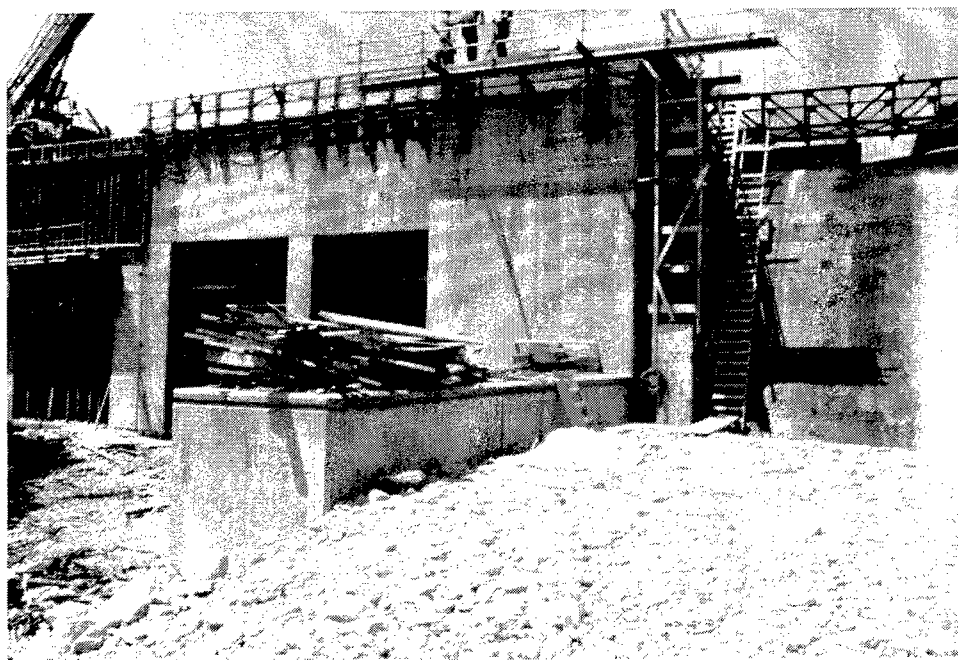
The boiler house monolith was extensively modified. Rehabilitation included removal of a large portion of the downstream section, resurfacing vertical and horizontal surfaces, and filling existing openings. Conventional concrete was used, and a new metal maintenance building was erected on top of the rehabilitated monolith (Figure 17).

Figure 17. Boiler house after rehabilitation, Brandon Road Dam

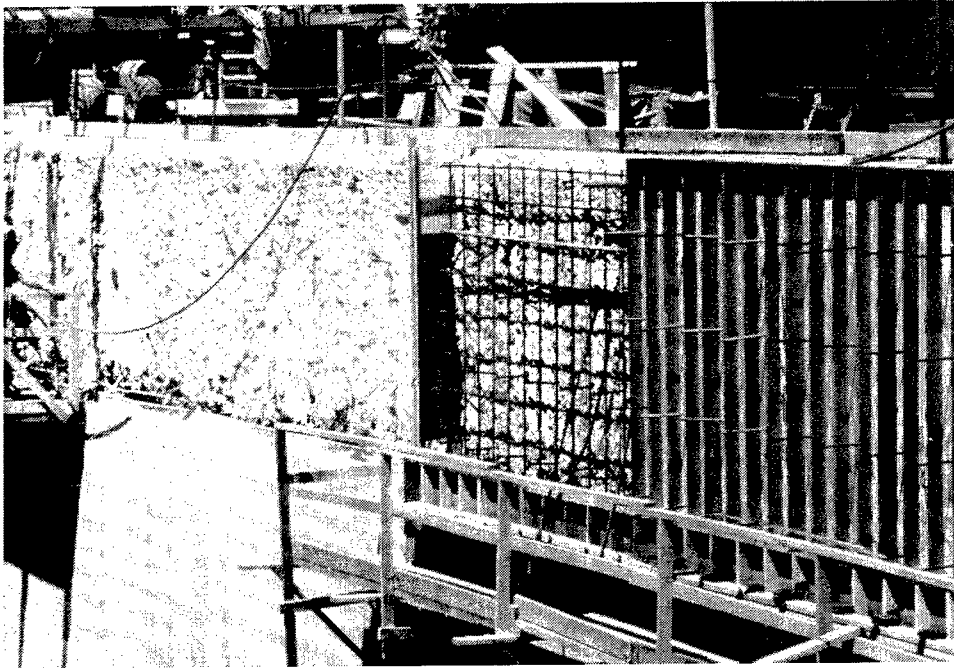
The head gate closure panels were installed on the downstream face of the structure. The panels, which were 4.6 m (13 ft 4 in.) wide, 4.9 m (16 ft) high, and 1.2 m (4 ft) thick, were reinforced with No. 6 steel bars on 305-mm (12-in.) centers each way on both faces. No. 6 steel bars on 457-mm (18-in.) centers vertically were used to anchor the panels to the existing piers. Anchors were also installed at the bottom of the panels (Figure 18). The head gate section after rehabilitation is shown in Figure 19.

Figure 18. Reinforcing and forms for head gate closure panels at Dresden Island Lock and Dam

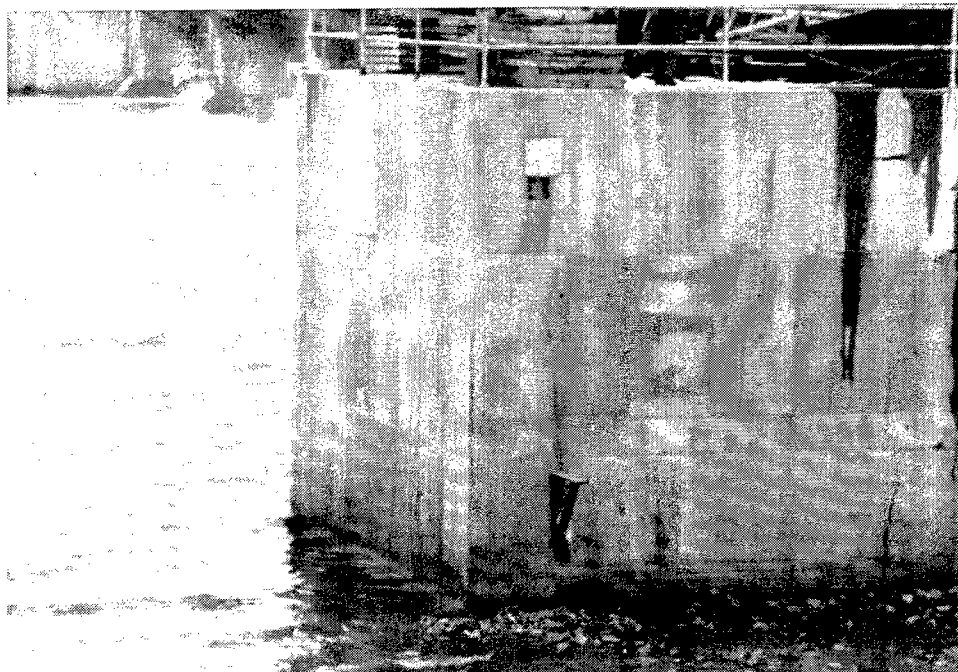
The procedure for resurfacing the arch dam was similar to that used for the tainter gate section. Concrete removal on the arch section varied from 229 mm to 0.38 m (9 in. to 1 ft 3 in.). Line drilling, expansive grout, and chipping hammers were used to remove the deteriorated concrete (Figure 20). The arch dam after rehabilitation has been completed is shown in Figure 21.

Figure 21. The south abutment of the arch dam after rehabilitation, Dresden Island Lock and Dam

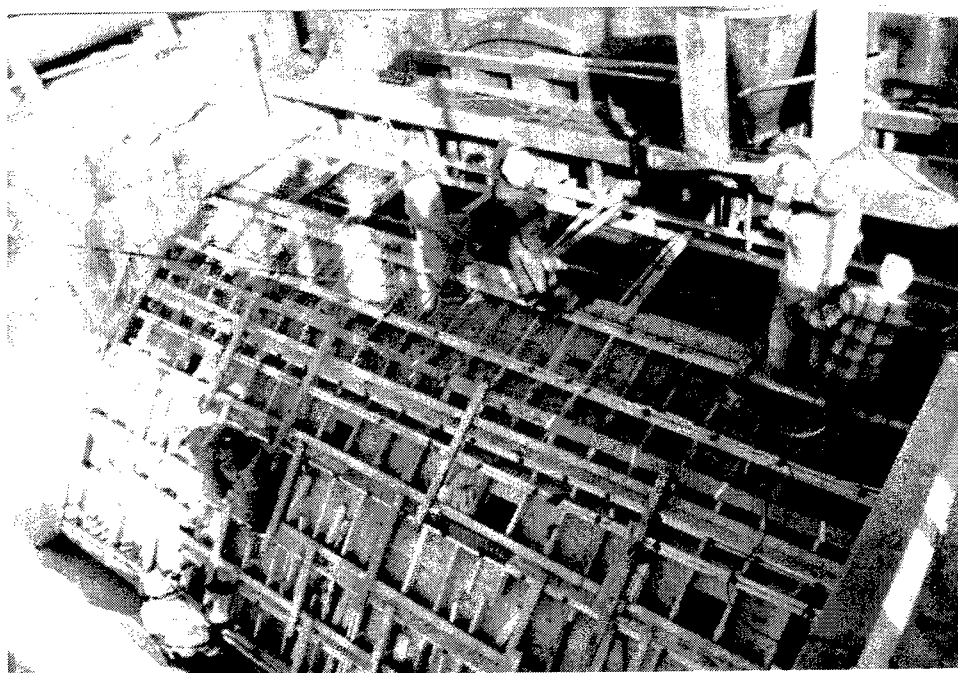
Figure 22. Concrete placed in the ice chute during conversion to ogee crest, Dresden Island Lock and Dam

The gated ice chute was converted to an uncontrolled ogee crest. Concrete was removed, forms were built, and the concrete replaced to obtain the ogee configuration (Figure 22). The converted ice chute is shown in Figure 23. The downstream face of the gate sill was resurfaced, and the gate recess in the sill was filled with concrete. The same methods were used to resurface this section as had been used on the arch dam.

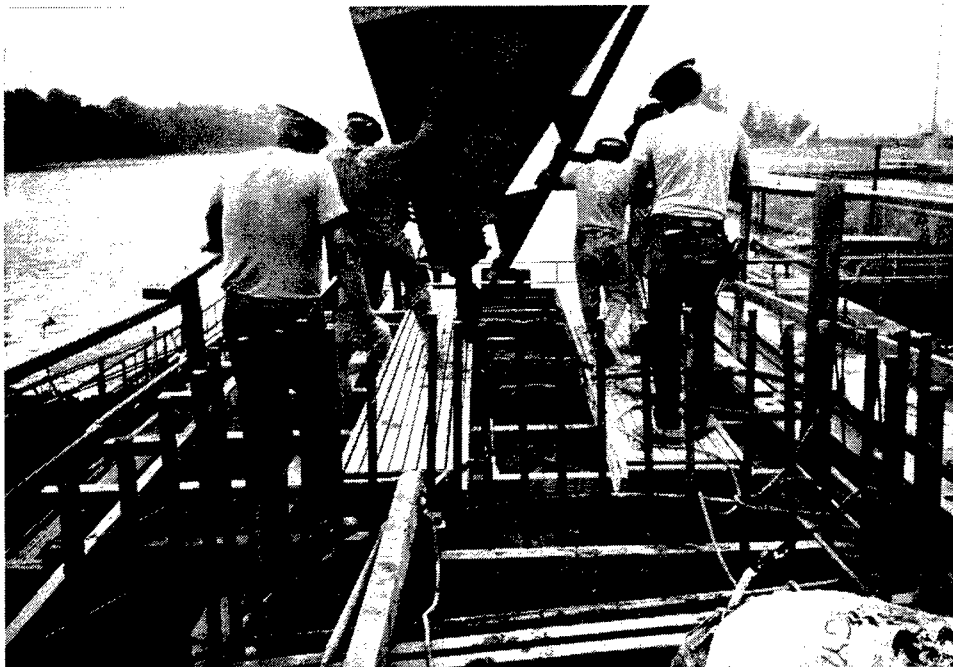
Figure 25. Concrete placement in riverward pier at LaGrange Lock and Dam

A concrete pier, 27.4 m (90 ft) long, 4.9 m (16 ft) wide, and 12.2 m (40 ft) high, a new gate sill, 35 m (115 ft) long, 26 m (85 ft) wide, and 3 m (10 ft) thick, and a half pier section were constructed to accommodate the submersible gate. Ready mix trucks were used to transport the concrete from a plant about 20 minutes from the dam. The trucks were loaded onto a barge; concrete was discharged into buckets and transferred by a crane to the forms (Figure 25). Lifts were restricted to 2.3 m (7-1/2 ft). Vibrators were used to consolidate the concrete, which was then moist-cured where possible; curing compound was used where necessary. A high-pressure water jet was used to clean lift joints. The last step was to place the gate between the new piers (Figure 26).

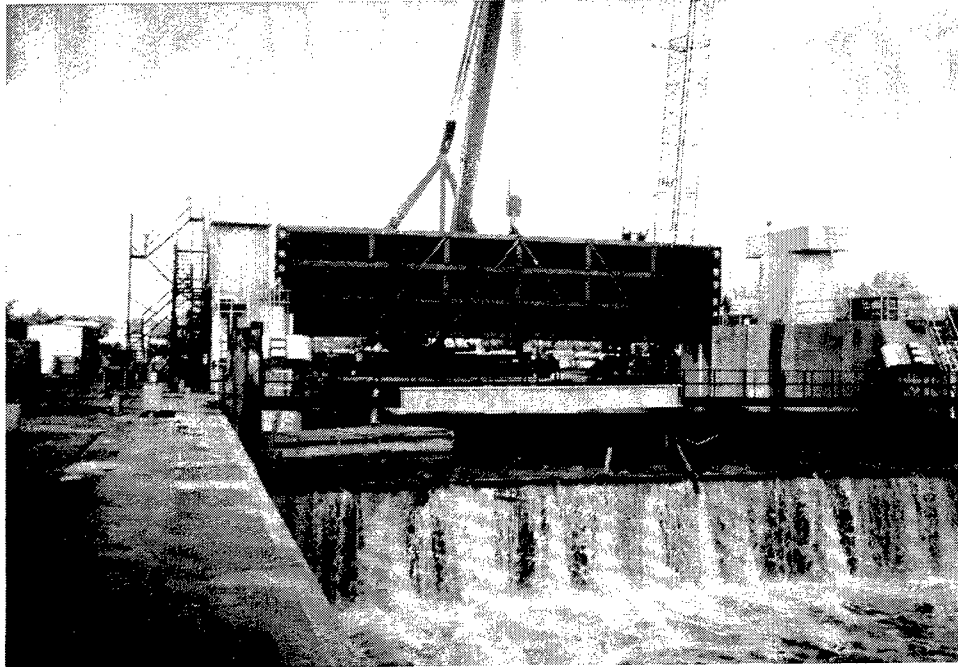
Figure 26. Placing of submersible gate, LaGrange Lock and Dam

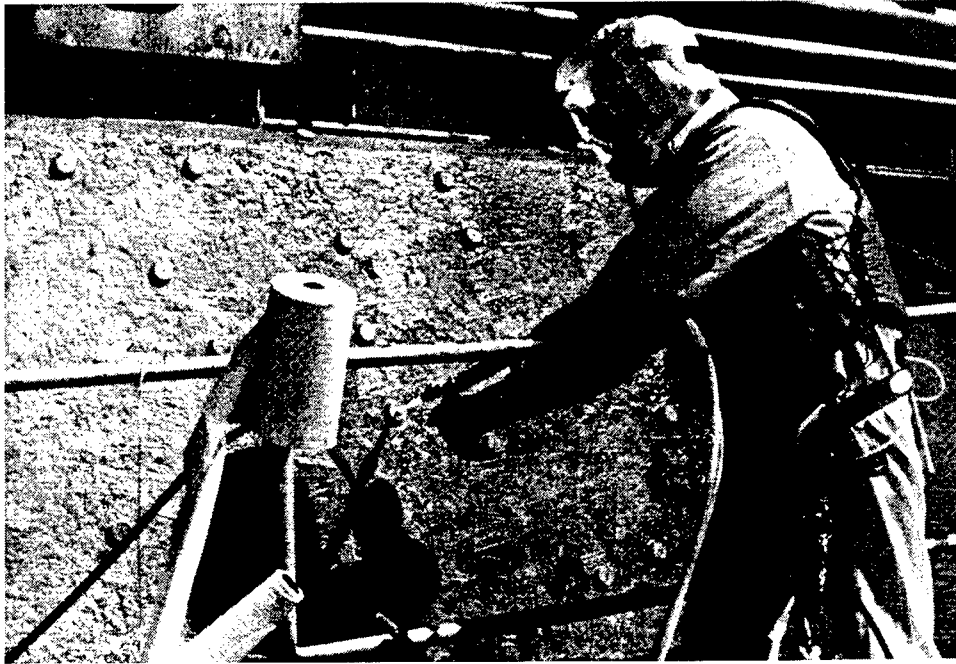
Lock and Dam No. 20 is located upstream of Canton, MO. The 699-m- (2,294-ft-) long structure includes a 653-m (2,144-ft) section that contains 40 tainter gates and 3 roller gates and a 46-m (150-ft) nonoverflow section. Over time the structure experienced concrete deterioration, especially around the tainter gates and service bridge piers. Cause of the deterioration is attributed to the lack of entrained air in the concrete, which decreased its resistance to cycles of freezing and thawing, alkali-silica reactions, and ponding of water on the tops

of the piers, which contributed to the extreme cracking and leaching in these areas.

Figure 27. Epoxy injection of pier stem at Lock and Dam No. 20, Mississippi River

In August 1982, Pier 39 was selected as a test site for in situ repair of cracked concrete (Doak 1988). The repair method was to use high pressure to inject a low-viscosity epoxy grout into the crack. The worst areas of deterioration on the pier were so severe that intact cores could not be extracted, and the crack system was too extensive for individual crack repair to be considered. The contractor had 25-mm (1-in.) injection ports installed in a grid pattern. The pier faces were sandblasted to ensure that they were clean, and then water was injected to locate extensive interconnection. The pier was sealed with a trowel-on epoxy, and then low-viscosity epoxy was injected through the ports with pressures up to 1.1 MPa (160 psi). The injection procedure was downward from the top of the pier, upward in the archway, and horizontally on the downstream and east sides; the upstream and west sides were not injected. Approximately 30 l (8 gal) of epoxy was injected into the pier.

A further test of in situ repair was conducted on Pier 27 during August 1987 (Webster, Kukacka, and Elling 1989). For this test, an ultra-low-viscosity material was used, and injection was made through holes in wood dowels bonded directly to the concrete surface (Figure 27). This test demonstrated that pressure injection repair techniques can restore the integrity of cracked concrete hydraulic structures.

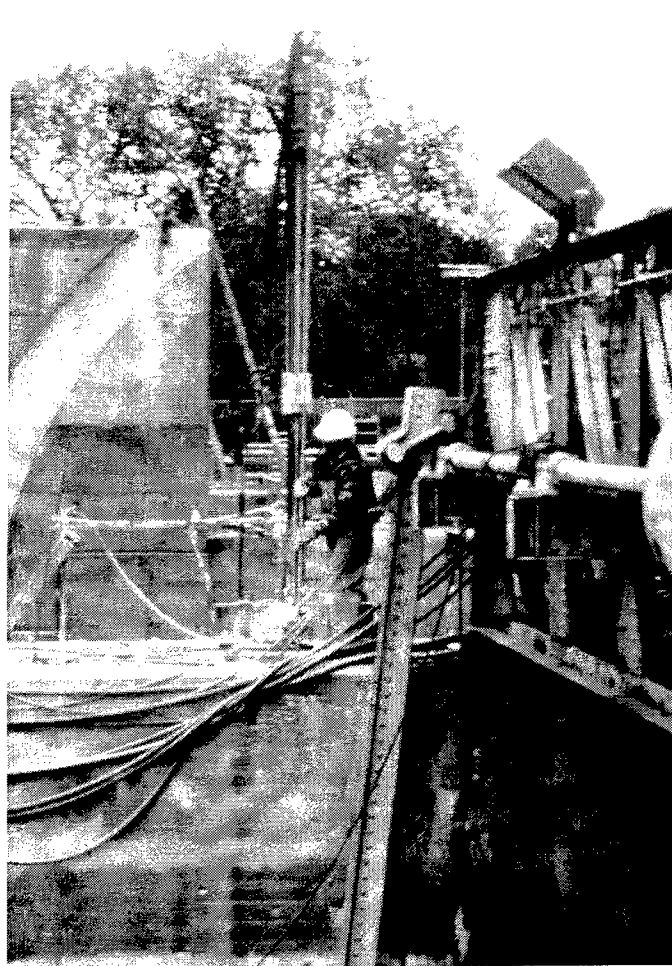
Figure 30. Line drilling for concrete removal at Marseilles Dam

from 102 to 254 mm (4 to 10 in.) deep and that the compressive strength of sound concrete was from 55 to 69 MPa (8,000 to 10,000 psi). Damaged concrete was removed to sound concrete, approximately 229 mm (9 in.). Deteriorated concrete was line drilled (Figure 30) and then removed with jackhammers and expansive grout. Diamond wire cutting was used to remove end blocks of concrete from the piers to allow for the installation of the new trunnion supports (Figure 31). With a cutting speed of 0.9 to 3.7 sq m/hr (10 to 40 sq ft/hr), the diamond wire was faster than conventional methods, and it required fewer workers. The pier sections were cut free in two work shifts.

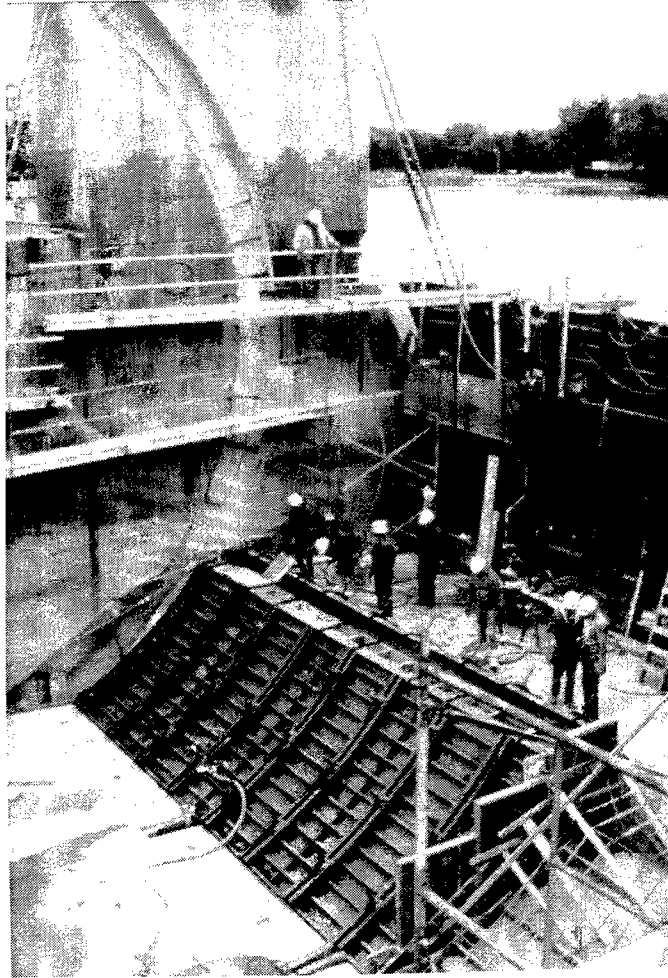
Figure 32. Concrete placement in new gate sill, Marseilles Dam

All horizontal surfaces were sloped slightly to prevent water ponding. A 0.5-m- (14-ft-) high extension was added to each pier so the gates could be raised to maximum elevation. Sills for the tainter gates were altered from an ogee shape to one that would allow the gates to be submerged (Figure 32). Posttensioned tendons on the pier sides were used to support the trunnion anchor beam and resist trunnion loads. The tendon load was transferred into the parent

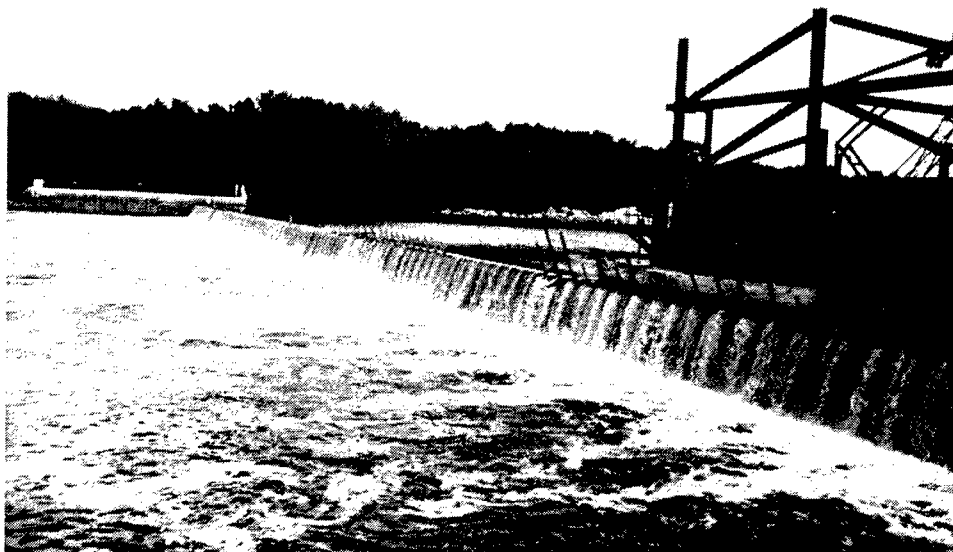
The wicket dam allows towboats to bypass the lock in open-pass navigation when flows are sufficient to lower all of the wickets. This condition occurs about 40 percent of the time during a year. There are, however, several problems with wicket dams, the biggest being that ice and debris cannot pass through the dam while the wickets are raised, which they must be during low river flows. Even the flip-top, hinged wickets, which can lower the top 0.9 m (3 ft), cannot sufficiently pass heavy ice flows. The dam had no other section for passing ice or debris. Backed up ice inhibits the movement of tows and slow lockages; ice lockages are frequently required to remove large quantities of ice while tows wait for a clear lock. Other problems with the wickets are that, in the lowered position, they pass a column of water that causes severe scouring action. Also, raising or lowering the wickets as flows change is a slow process.

Figure 33. Peoria Dam before a section of the wicket dam was replaced with a submersible gate

To alleviate some of the problems of the wicket dam and to provide ice passage capability and a safer means of regulating flow, a section of the wicket dam was replaced with a 25.6 m (84-ft) wide, submersible gate adjacent to the lock wall. Appurtenant piers, gate sills, an apron, and a service bridge were included in the modification plan.

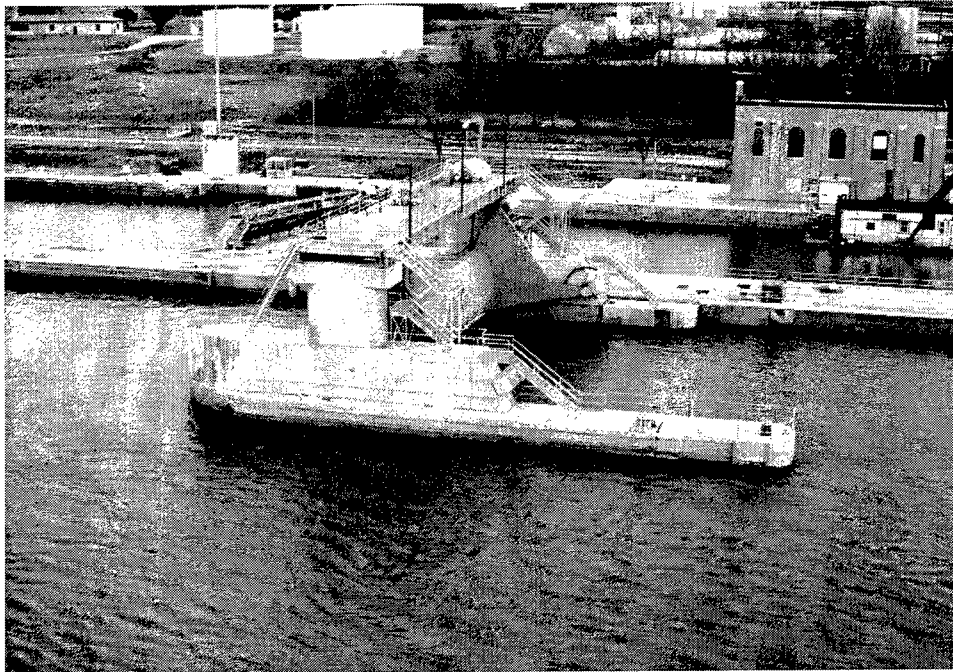
Figure 34. Completed piers and gate constructed at Peoria Dam

The report of the Fifth Periodic Inspection (USAED, Rock Island 1991c) noted a fine longitudinal crack in the riverward pier; otherwise, concrete in the dam was reported to be in excellent condition.

Ready-mix trucks were used to transport the concrete from a plant about 20 minutes from the dam. The trucks were loaded onto a barge; concrete was discharged into buckets and transferred by a crane to the forms. Lifts were restricted to 2.3 m (7-1/2 ft). Vibrators were used to consolidate the concrete, which was then moist-cured where possible; curing compound was used where necessary. A high-pressure water jet was used to clean lift joints. The completed piers and gate are shown in Figure 34.

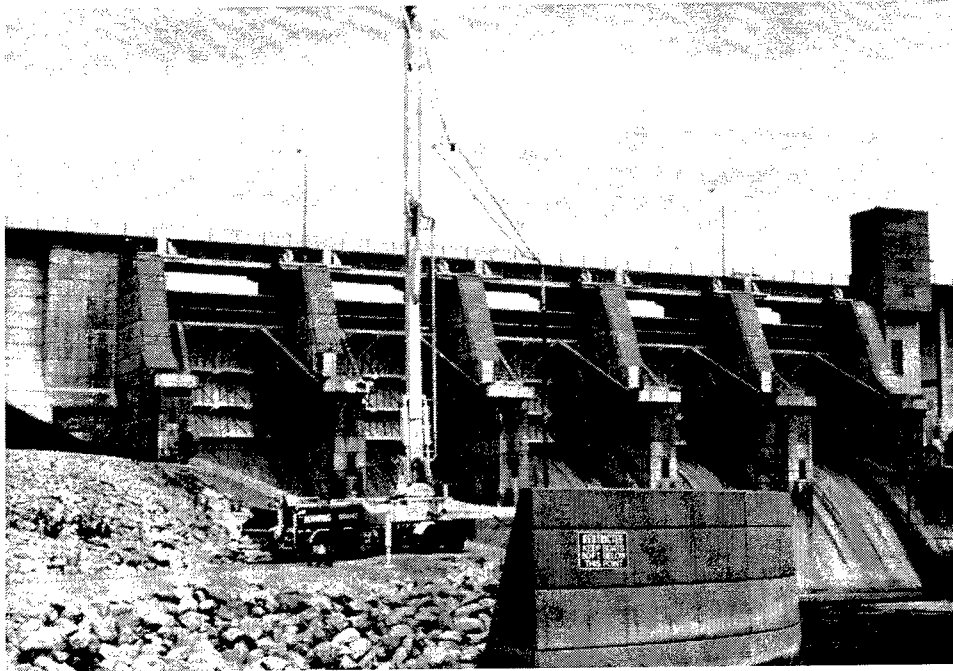
Figure 36. Concrete pump used for end sill repair at Red Rock Dam

Concrete mixture proportions for 1-cu m (1-cu yd) batch were 415 kg (700 lb) of Type 1 Portland cement, 729 kg (1,229 lb) of fine aggregate, 946 kg (1,594 lb) of coarse aggregate, 163 kg (275 lb) water, 0.19 ℓ (5 fl oz) of antiwashout admixture, 1.63 ℓ (42 fl oz) of water reducing admixture, and 0.80 ℓ (2 fl oz) of air-entraining admixture. The concrete was delivered to the job site by truck mixers, each arriving about 2 min after the previous truck had finished unloading. Haul time was approximately 15 min. A 102-mm- (4-in.-) diam pump line controlled by a diver was used to place the concrete approximately 7.6 m (25 ft) underwater (Figure 36). Placement began at the middle of the end sill and worked toward the north bank. During placement, water was discharged through the dam at a minimum 8.5 cms (300 cfs), and the river water temperature was about 26 °C (80 °F). The end of the pump line was kept embedded in the mass of concrete being discharged; the diver moved the line around to completely fill the repair area. Approximately 31 cu m (40 cu yd) of concrete was placed in the northern half of the end sill in about 1-1/2 hr.

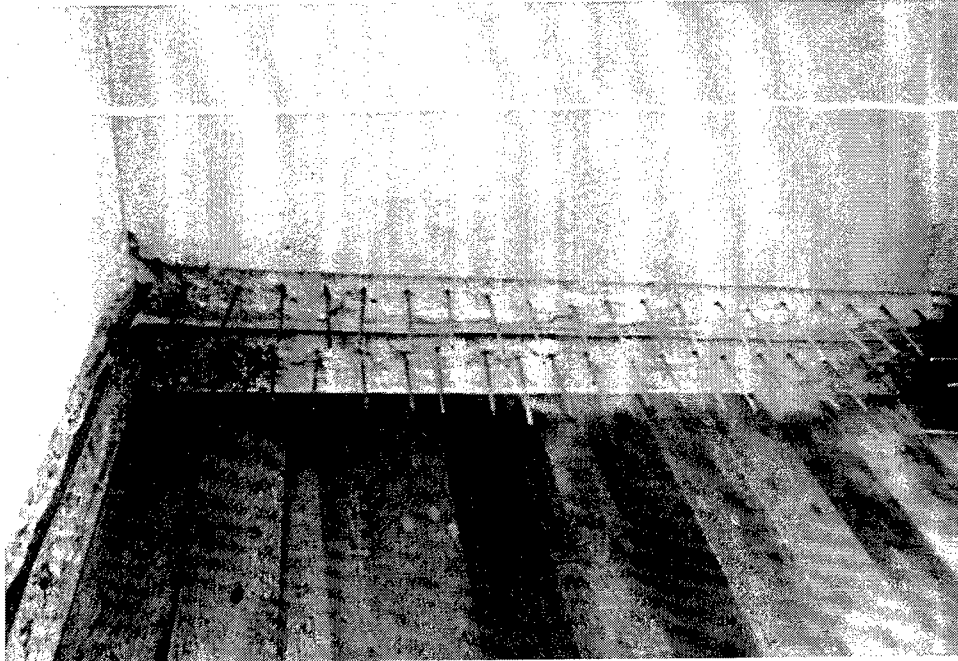
Figure 37. Anchors and waterstop installed in head gate section, Starved Rock Lock and Dam

The closure panels for the head gate section were 4.3 m (14 ft) wide, 4.9 m (16 ft) high, and 0.8 m (2 ft 6 in.) thick. Two rows of No. 6 steel bars on 229-mm (9-in.) centers were installed to anchor the panels (Figure 37). Deteriorated concrete was removed from the roof of the head gate opening, and a waterstop was installed along the perimeter of the opening. The concrete for the closure panel was pumped to just below the roof opening (Figure 38), and then the opening was filled with nonshrink grout. Vibrators were used to consolidate the concrete. A curing compound was used for curing.

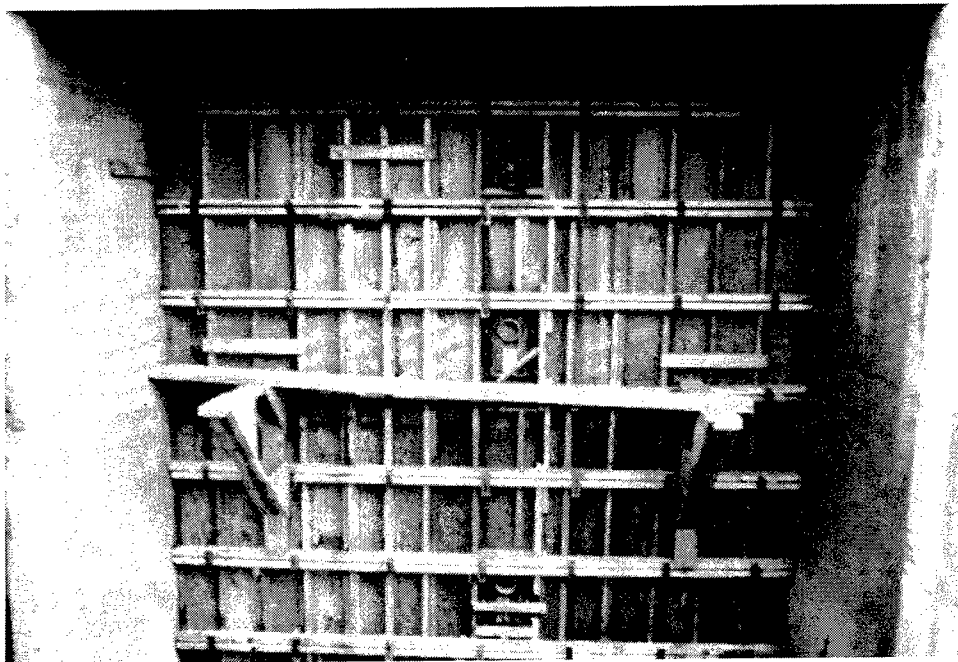
Figure 38. Forms and openings for pumping concrete for closure panels in head gate section, Starved Rock Lock and Dam

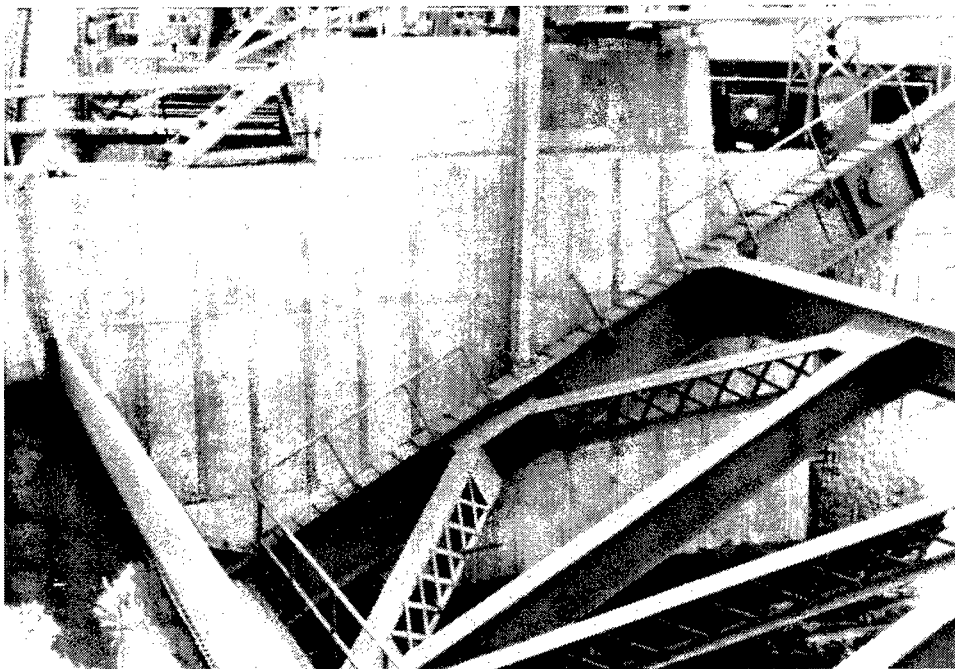
Figure 39. Tainter gate pier after rehabilitation, Starved Rock Dam

Concrete was removed to a depth of 152 mm (6 in.) for vertical and horizontal resurfacing. The replacement concrete was anchored to the piers with No. 6B steel bars on 0.6-m (2-ft) centers. Reinforcing consisted of welded wire fabric. A steel angle was embedded at the upstream bullnose of the piers. The contractor was concerned about being able to place the required 19-mm (3/4-in.) maximum concrete in the relatively narrow 152-mm (6-in.) section, which was congested with anchors, reinforcing, and other embedded items, so he requested permission to use a high range water reducer admixture (HRWRA) to increase workability of the concrete.

Ready-mix trucks carrying the concrete were transported by barge to the tainter gate section. A crane and bucket were used to place the concrete. A curing compound was used for curing the concrete. The rehabilitated tainter gate is shown in Figure 39.

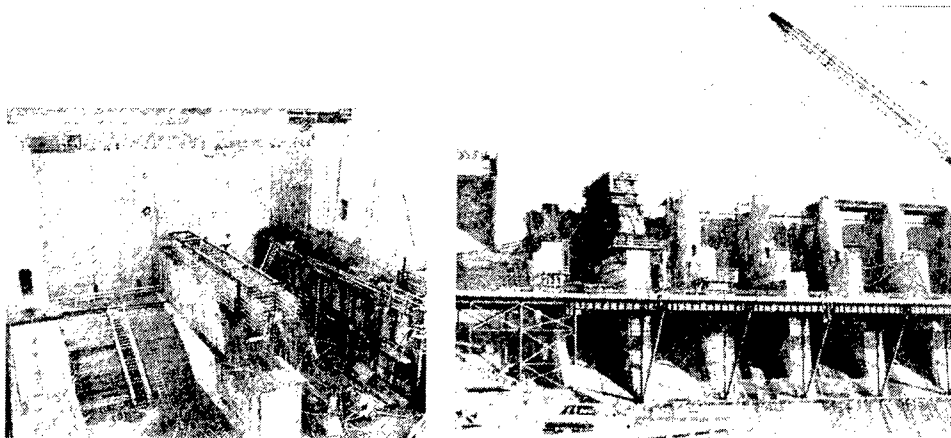
Figure 44. Piers raised and widened to resist greater head at Chief Joseph Dam (from ENR 1978)

contractor developed a plan for concrete removal that included presplitting the pier noses with drills and then placing fractions of dynamite sticks in the holes and detonating them with blasting cord. With this method, a pier top could be removed in about 3 weeks. Installing dowels and rebuilding the piers took several months (Figure 44). When work on a pair of piers was completed, the crew placed stop logs in the bays and then moved the

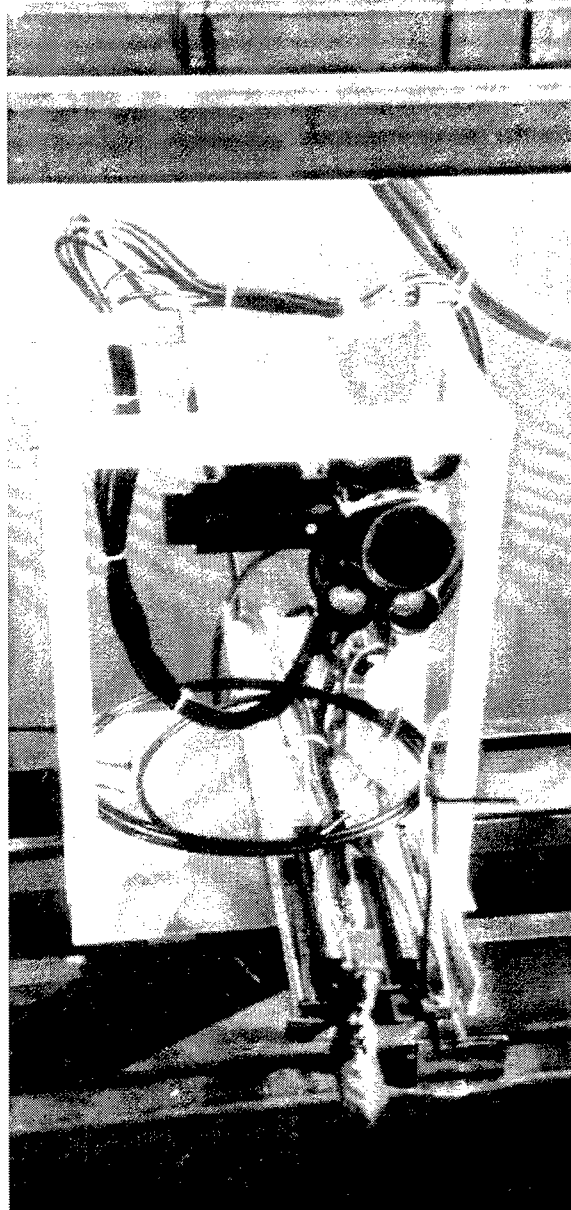
Figure 46. Frame-mounted remote-controlled camera and pneumatic equipment used for inspection and repair of monoliths at Chief Joseph Dam (from ENR 1978)

All repairs were performed underwater. A remote-controlled camera with a 360-deg pan, 360-deg tilt, and 8-power zoom was used to monitor the repair work. A pneumatic grout pump supplied grout to the application nozzle, and a pressure pot supplied dye to leak-detection equipment. The camera, cleaning equipment, dye injection hose, lights, and grout injection nozzle were mounted on an underwater frame supported by a crane. A pneumatic motor moved the cleaning-inspection-grouting equipment along the length of the frame, which was positioned over a lift joint (Figure 46). Controls for the camera, lights, and grouting equipment were on top of the spillway bridge. As each joint was sealed, the amount of leakage through drain outflows was measured and inspected visually. The leakage reduction in each instance was significant.

The repair procedure involved locating the leakage points and applying the sealant. A pneumatic grout pump with a 30:1 ratio and up to 11.4-lpm (3-gpm) delivery was used to pump the grout. Since the water movement into the joints had a significant attractive force, the sealant not only sealed the joint entrance but was also drawn into the joint interior for a short distance (induction grouting).

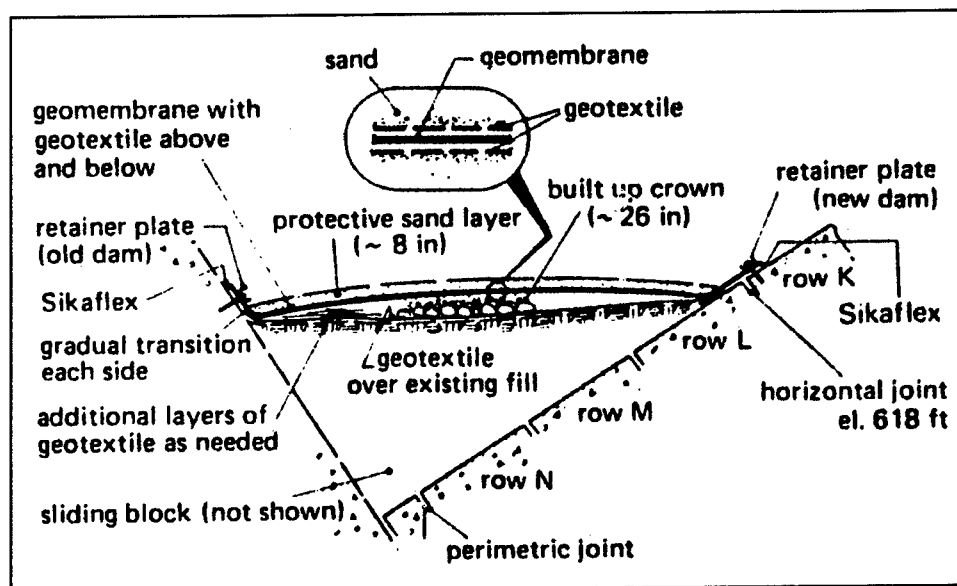
Figure 49. Details of installation of geomembrane over toe fill at New Exchequer Dam (from Brown and Kneitz 1987)

Although the toe fill was in good condition, with no sinkholes, the repairs planned for this area were completed (Figure 49). Two light bulldozers were used to remove extraneous material and grade the fill. Next, a layer of geotextile was placed over the fill, followed by imported material dumped from the crest of the old dam and spread by the dozers. This material was covered with a second layer of geotextile. A watertight geomembrane was placed over this layer of geotextile. The geomembrane had been precut and seamed in three large panels. An additional piece had to be added because of the difference between the expected and actual toe-fill geometry and to provide for adjustment of the membrane to the toe fill after the reservoir filled. A tented enclosure and heaters were used to maintain proper temperatures for making the field joints.

The geomembrane was covered with a layer of geotextile topped with a layer of sand. The entire toe-fill repair was carefully wetted, and then the area was rewatered. By mid-January 1986, the water level had reached el 706 and had a static head of 26.8 m (88 ft) on the surface of the toe fill. No measurable leakage had occurred. The reservoir continued to fill; not until 3 March 1986, were traces of leakage noted. When the reservoir peaked 28 June 1986, 3.4 m (11 ft) below normal maximum reservoir level, leakage was 0.098 cms (3.5 cfs), a significant reduction when compared to leakage of 3.9 cms (140 cfs) at this same level in 1983. Leakage at the dam reported in July 1986 was 0.1 cms (3.7 cfs). Some personnel believe as much as half of this amount is coming through the old dam gallery and the new dam access gallery.

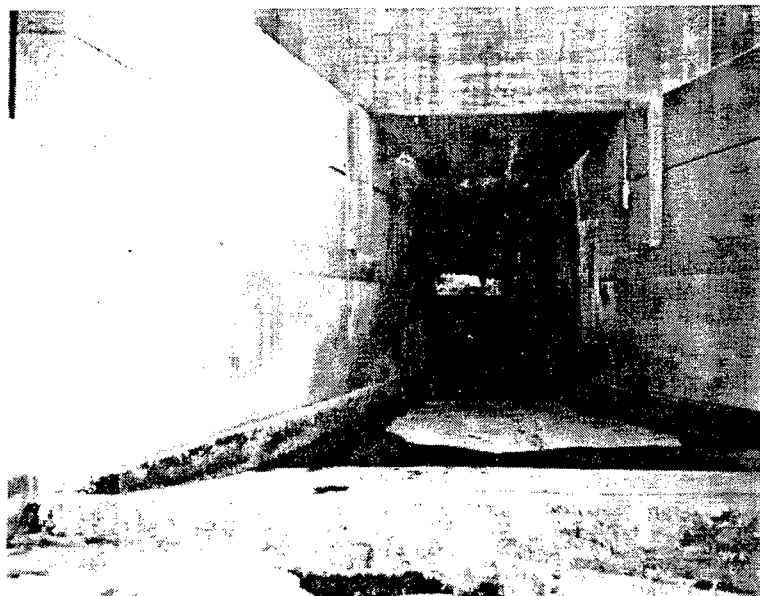
Figure 52. Outlet channel of flip bucket no. 4 with steel plates on the walls, Lucky Peak Dam (from U.S. Army Engineer District, Walla Walla 1983)

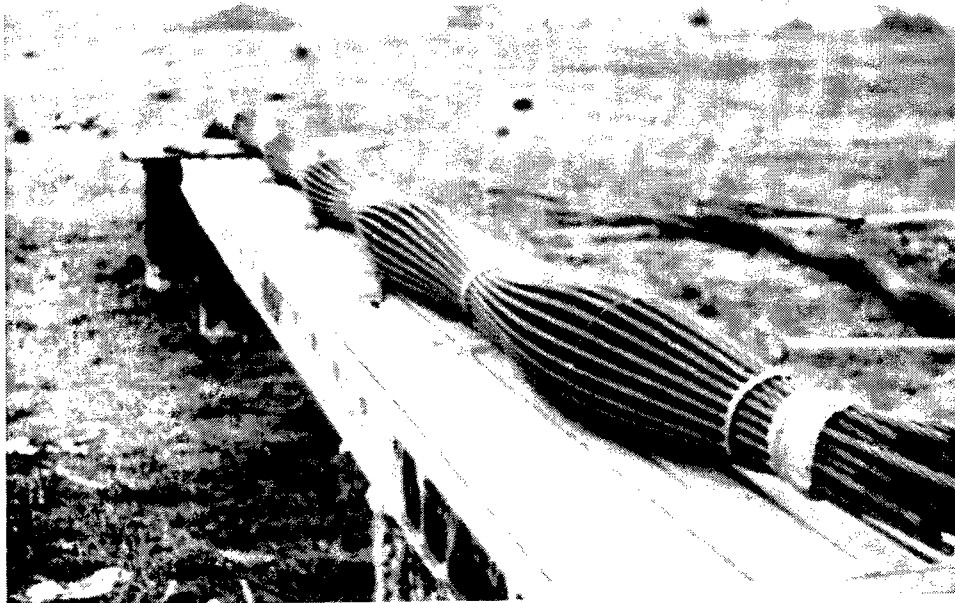
Figure 55. Anchor strands, cut and bound, for Alum Creek Dam (from Barnes 1982a)

Another contract alteration allowed the contractor to use a 52-strand anchor with a minimum of 1,900 MPa (275 ksi) per strand instead of the designed 53-strand anchor with 1,700 MPa (250 ksi). The strands were cut and bound together (Figure 55) to form an anchor. A helicopter was used to install the anchors; each anchor unit weighed approximately 1,540 kg (3,400 lb). The operation was completed in 5 hr on 6 September 1977. The next 3 days were used to grout the anchors in place. The grout contained 19 ℓ (5 gal) of water per bag of cement and 1-percent Intraplast-N. Fifty one-millimeter- (2-in.-) cube specimens were taken and tested at both 7 and 21 days; they passed the contract specification of 27.6 MPa (4,000 psi) with compressive strengths of 29.1 and 42.7 MPa (4,220 and 6,200 psi), respectively.

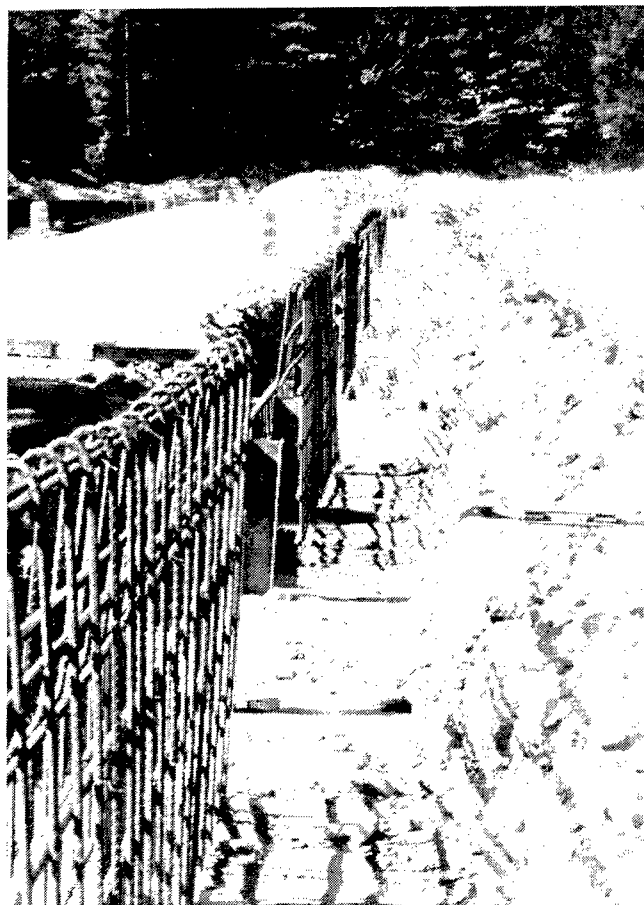
Figure 56. Construction of a parapet wall on the upstream crest of Mohawk Dam (from U.S. Army Engineer District, Huntington 1990b)

The procedure for raising the crest of the dam was to place a layer of random fill on the upstream face of the embankment and then cover it with a layer of random rock fill. The original upstream slope varied from 2 to 3:1. The rock fill and random rock blanket provide a 4:1 stability berm to el 840 where a 15.5-m- (50-ft-) wide bench was constructed. The 4:1 slope continues above the bench to el 891 where it transitions to 2.5:1 and continues from there to the crest. Because space near the intake structure was limited, it was not possible to maintain the 4:1 stability berm cross section. In this area, select fill was placed on a 2:1 slope to el 900 before transitioning to a 2.5:1 slope from that point onward to the crest. The crest of the dam was covered with impervious fill. After the embankment was raised, a 0.9-m- (3-ft-) high concrete parapet wall was installed to provide the minimum required freeboard (Figure 56).

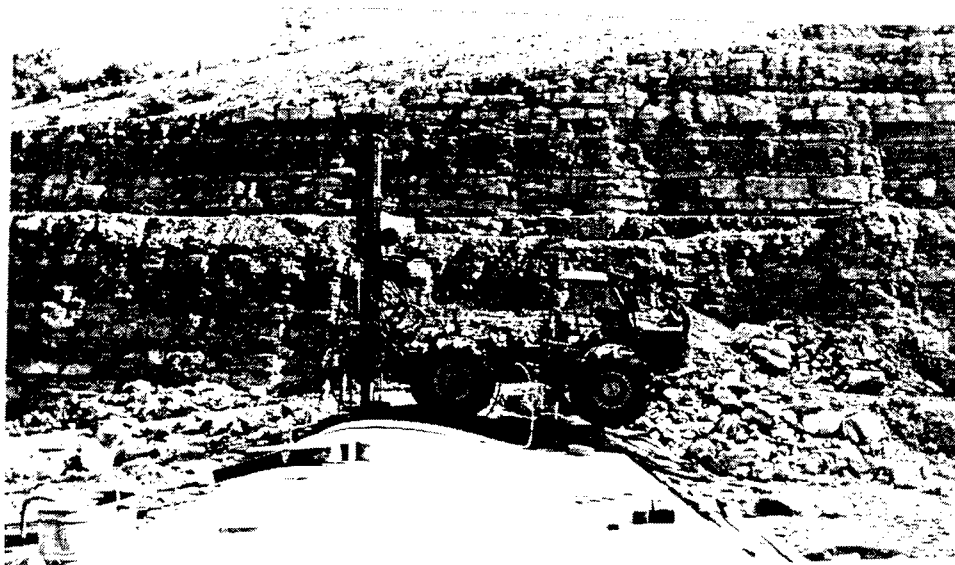
Figure 58. Holes drilled for installation of posttensioning anchors on spillway crest, Mohawk Dam (from U.S. Army Engineer District, Huntington 1990b)

The spillway was widened from 195 to 200 m (640 to 657 ft) to improve entrance conditions and to provide a suitable foundation for the newly added spillway approach sidewalls. A monolith was added to each end of the curved concrete weir that protects the spillway crest in the event of spillway flow (Figure 57). Concrete hang-on walls for the spillway approach were constructed at the contacts between the weir and the excavated spillway sidewalls. A one-row grout curtain, 9 m (30 ft) deep, 3-m (10-ft) centers was also placed along the line of the concrete weir. Additionally, the concrete hang-on walls and the existing weir monoliths were anchored into the rock. No. 8 reinforcing bars were grouted into drill holes spaced on 3-m (10-ft) centers (Figure 58). The anchors were then posttensioned to 149 kN (33.5 kips).
